Inspection Report

Property Address: 8 Cherokee Dr Moultrie GA

Premier Home Inspections of Valdosta, LLC

Date: 7/11/2014	Time: 09:00 AM	Report ID:
Property:	Customer:	Real Estate Professional:
8 Cherokee Dr	Betty Koukis	Kirk Friedlander
Moultrie GA		Matco

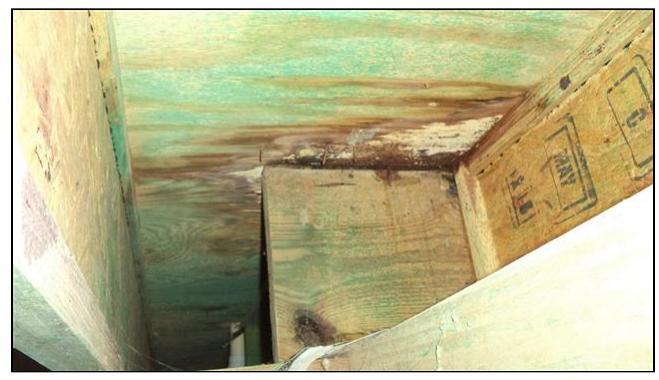
1.0 Moisture damaged subflooring is present at the front of the crawlspace near the porch. Water is seeping in through the brick and has damaged a small section of the flooring. A licensed contractor is suggested for repairs.

1.0 Item 1(Picture) Soft subflooring at the front of the space

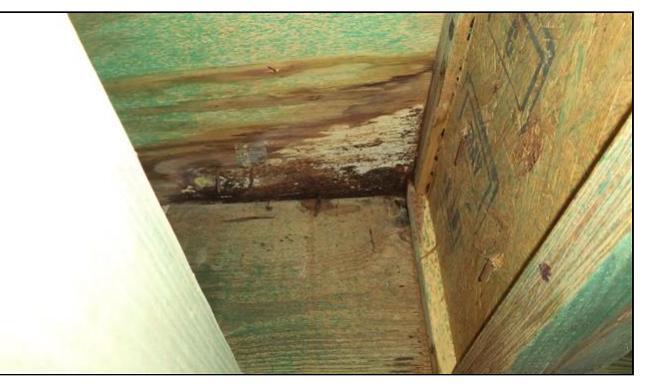
1.0 Item 2(Picture) Soft subflooring at the front of the space

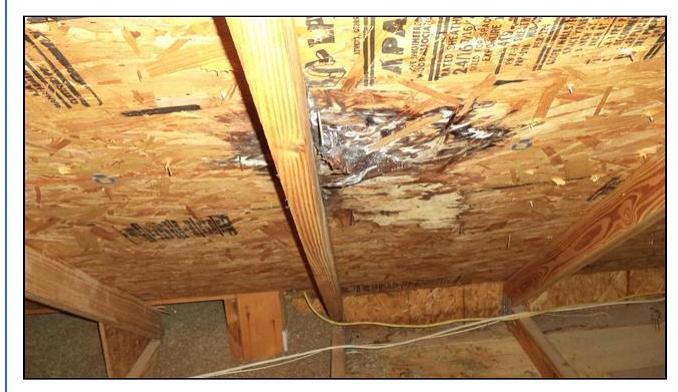
▲ 1.5 Two stains are present in the attic above the garage; the stain nearest the garage attic access is active and leaking. The decking is damaged and will also need repairing. It is unknown if the stain at the far end of this attic is active. A licensed roofer is needed for further inspection.

1.5 Item 1(Picture) Damaged decking in the garage attic from an active leak

1.5 Item 2(Picture) Stain in the garage attic near the front of the home

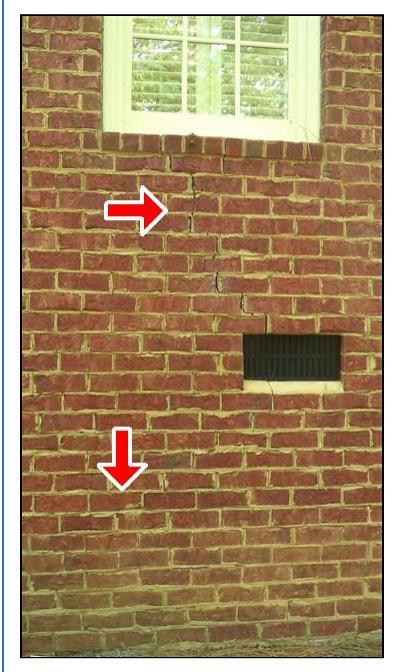
2.0 A settlement crack is located in the brick at the left side of the home. All cracks in the siding are suggested for further evaluation from a licensed contractor.

2.0 Item 1(Picture) Cracked brick at the left side of the home

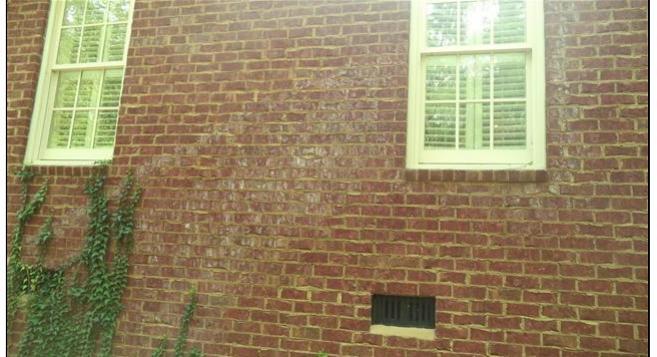
NOTE: Efflorescence is located on the brick at the left side of the home. This is a fine, white, powdery substance of water-soluble salts left on the surface of masonry as the water evaporates. This has not caused an issue or deficiency with the structure of the home.

2.0 Item 2(Picture) Efflorescence at the left side of the home

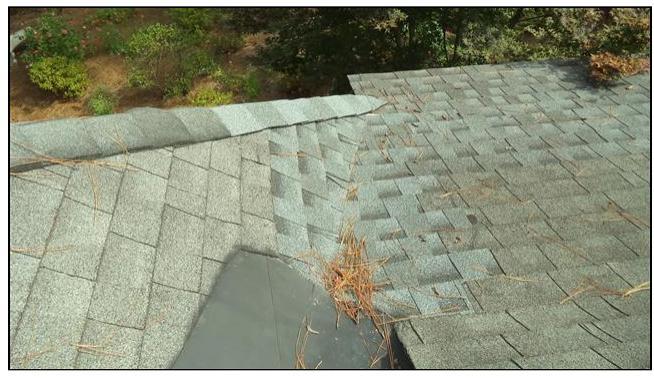
The shingles have a 30 year life expectancy; a licensed roofer is needed to inspect the center areas of roofing where the rooflines meet. This is a rubber / roll material. The roof above the garage is actively leaking. A shingle patch is present over the back of the kitchen / breakfast room.

3.0 Item 1(Picture) Shingle patch at the back

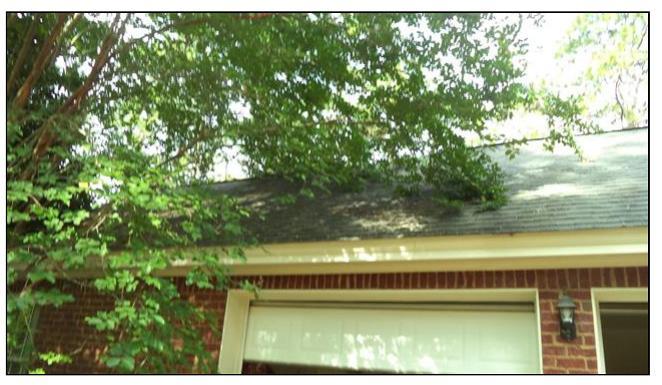
✓ 3.0 Tree limbs hang over the right side roof (garage) and will need to be trimmed back so the shingles are not scraped.

3.0 Item 2(Picture) Tree limbs touch the roof

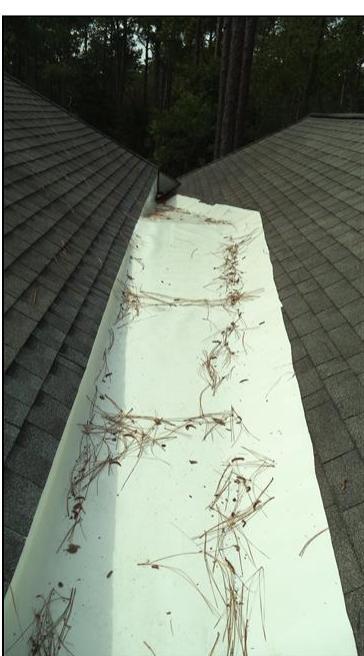
3.0 Item 3(Picture) Roofing above the master area between the rooflines

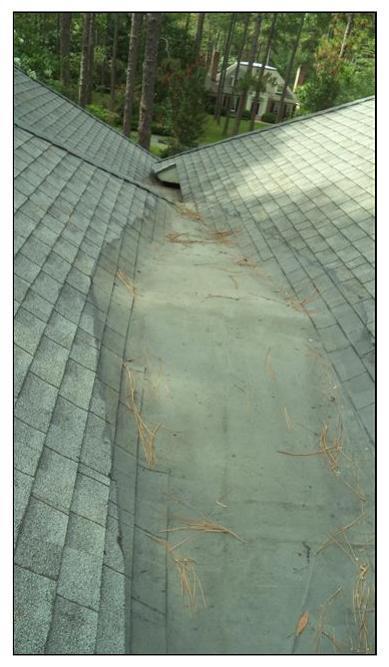
3.0 Item 4(Picture) Roofing between the rooflines over the garage

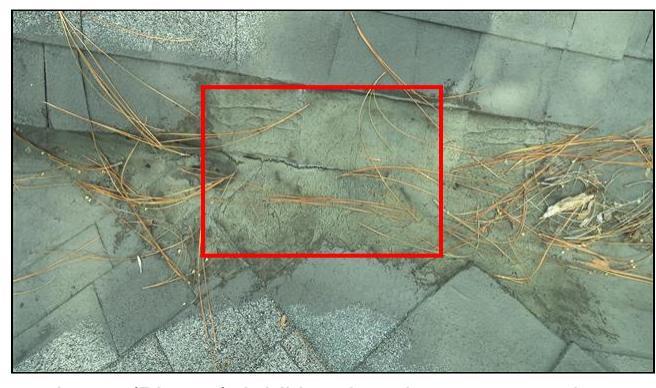
3.0 Item 5(Picture) Additional sealant suggested

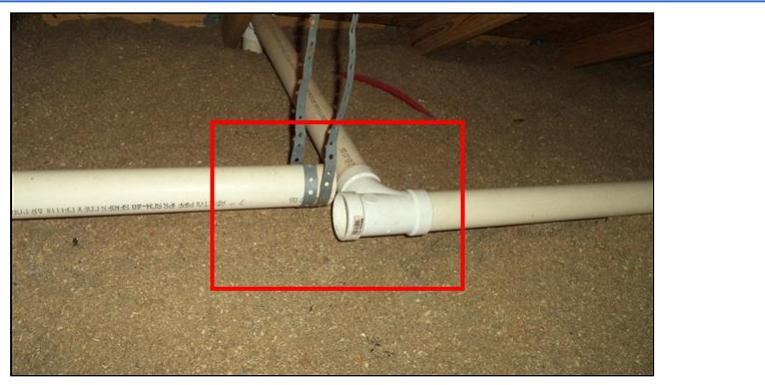
▲ 4.0 Over the garage, the vent stack has come disconnected and will need to re-connect to the main vent so all plumbing gases can escape to the exterior.

4.0 Item 1(Picture) Plumbing vent disconnected

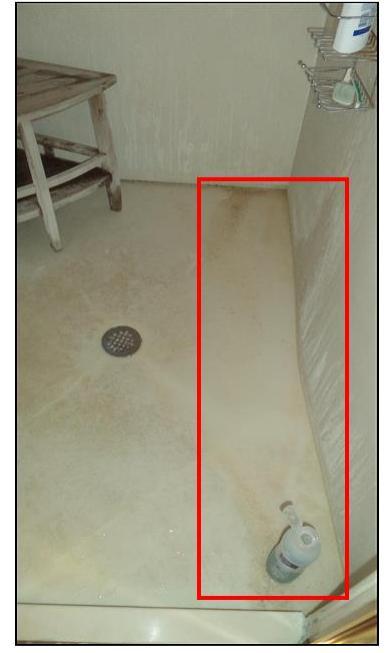
The master shower door does not properly close and latch; the top of this door is loose and does not secure in place. Also, there is a negative slope inside this shower with a bowed wall. In the crawlspace, heavy staining was found on the subflooring from prior leaking. A section of the structural support beam has been replaced under the shower. Repairs are suggested from a qualified professional so the water can properly slope to drain and the wall is no longer bowed.

4.1 Item 1(Picture) Standing water and bowed shower wall

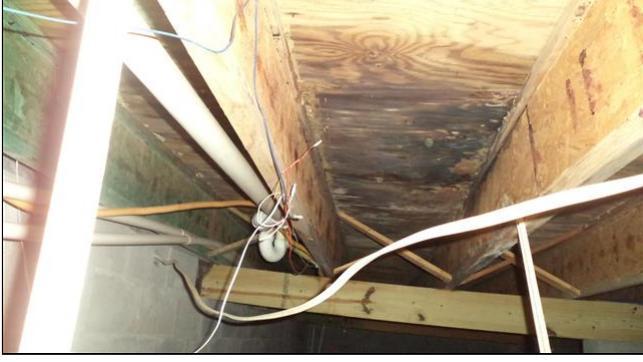
4.1 Item 2(Picture) Stained subfloor under the master shower

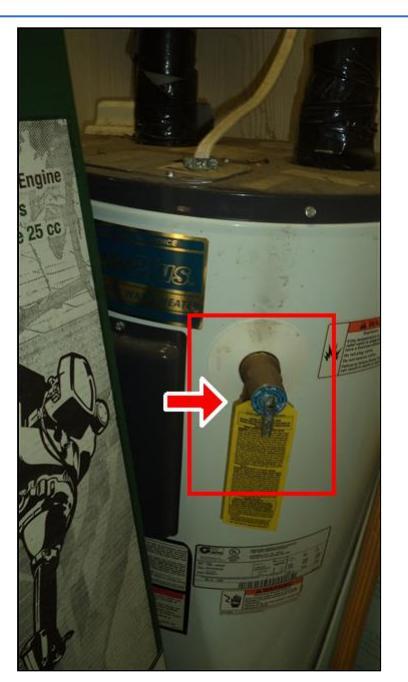
▲ 4.2 Both water heaters will need a PVC pipe attached to the TPR valves. The attached PVC is needed in case the tank needs to release temperature or pressure, it will release down the pipe instead of spew from the valve.

4.2 Item 1(Picture) Piping needed on the TPR valve

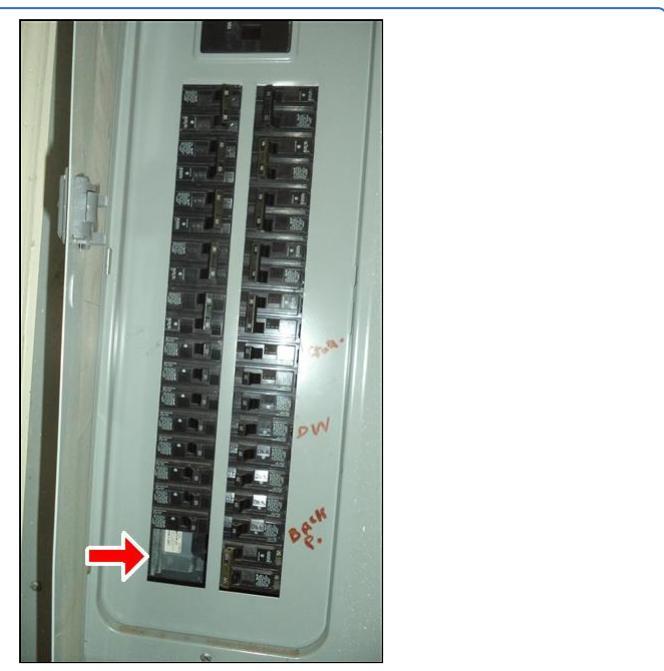
5.1 One breaker cover is suggested to be installed inside the main panel to cover an exposed opening.

5.1 Item 1(Picture) Breaker cover needed

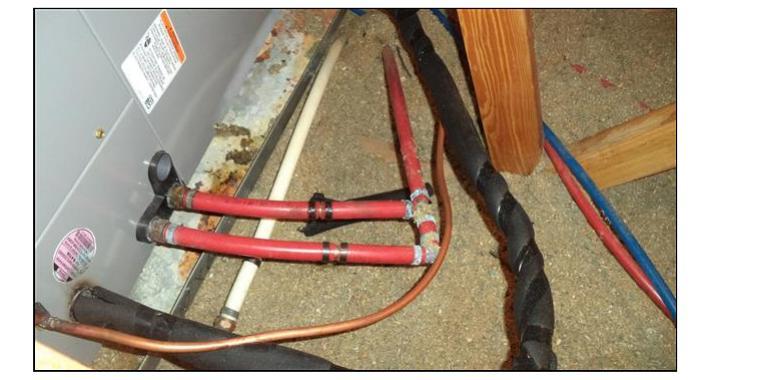
On all the air handlers, the drain lines are mostly pex piping instead of PVC material. A certified HVAC technician is suggested for another opinion on this type of material used for a condensate drain line.

7.1 Item 1(Picture) Pex piping used for drain line on the air handlers

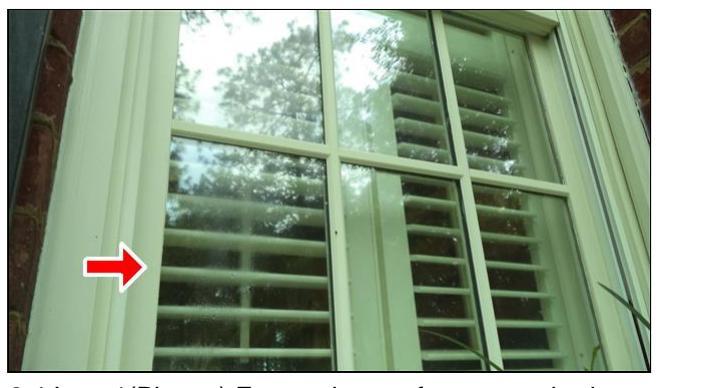
▲ 8.4 The front spare bedroom window has turned foggy and lost its seal in its lower pane. A small crack is present in this pane; replacement glass is suggested for correction.

8.4 Item 1(Picture) Foggy glass at front spare bedroom

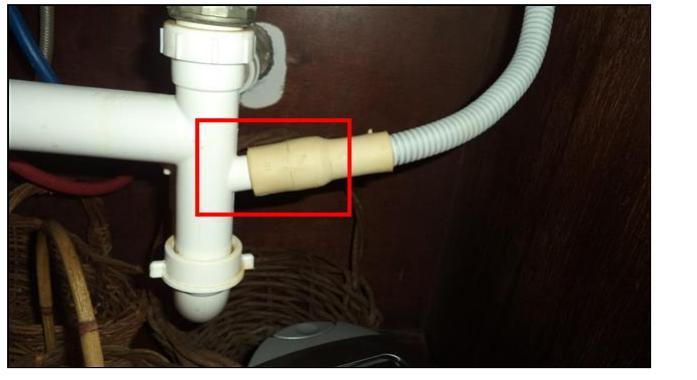
▲ ▲ 10.0 The dishwasher was not ran or cycled through because standing water is present inside the unit. Further evaluation is suggested from an appliance repair person to assess the drain line. Also, the drain line is not clamped. A clamp is needed.

10.0 Item 1(Picture) Clamp missing on the DW drain line

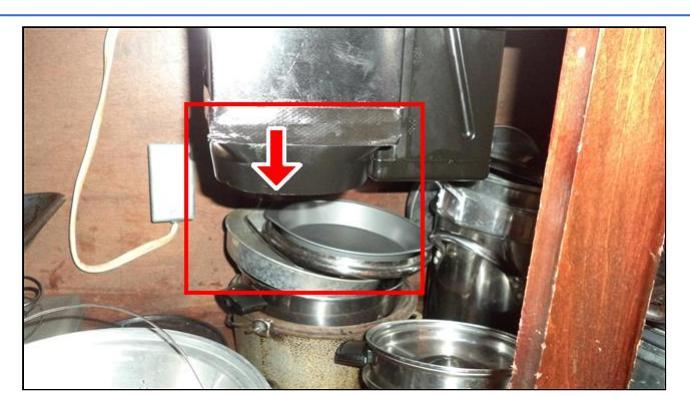
▲ 10.2 The down draft hood vent terminates into the cabinet below the stove top. It is best suggested that the exhaust terminate either in the crawlspace or exterior.

10.2 Item 1(Picture) Kitchen exhaust fan empties into the cabinet

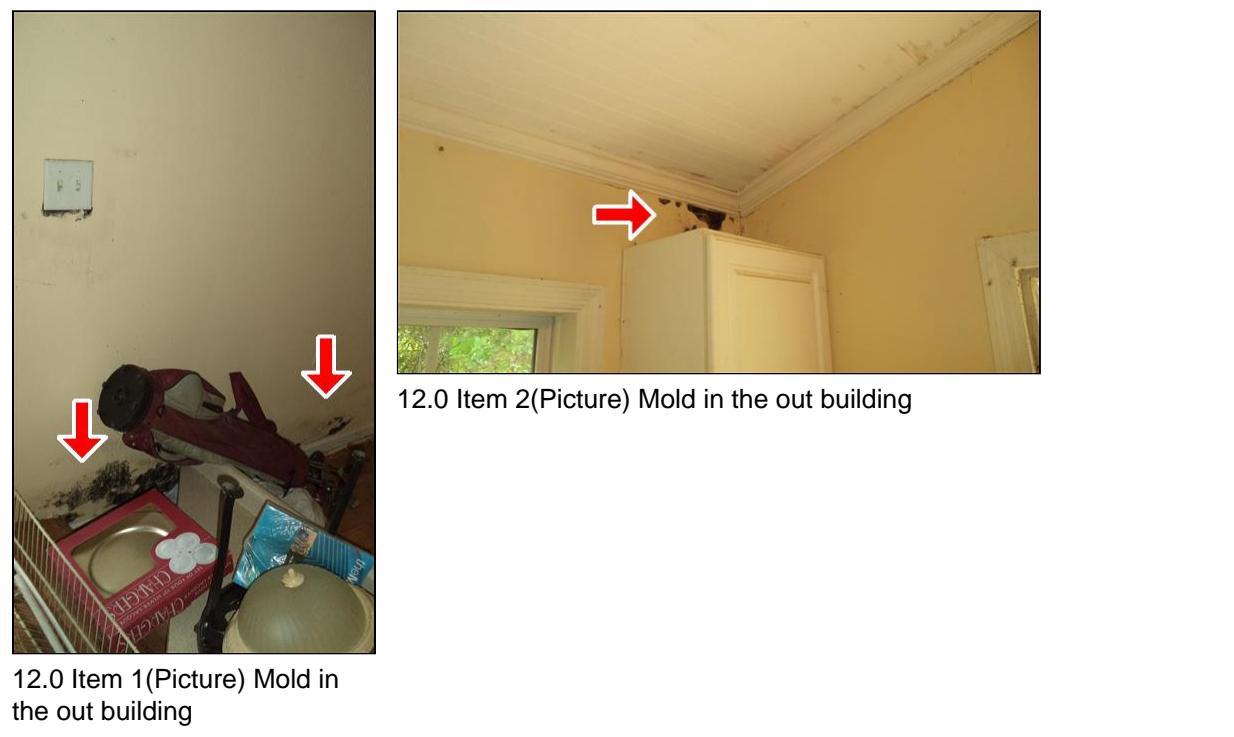
12.0 Mold is actively present in the back out building. Remediation is needed from a licensed removal company.

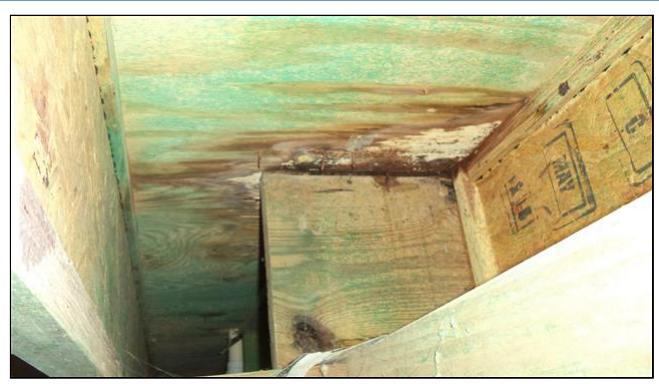
- 1.0 Foundations, Basements and Crawlspaces (Report signs of abnormal or harmful water penetration into the building or signs of abnormal or harmful condensation on building components.) Inspected
- Moisture damaged subflooring is present at the front of the crawlspace near the porch. Water is seeping in through the brick and has damaged a small section of the flooring. A licensed contractor is suggested for repairs.

1.0 Item 1(Picture) Soft subflooring at the front of the space

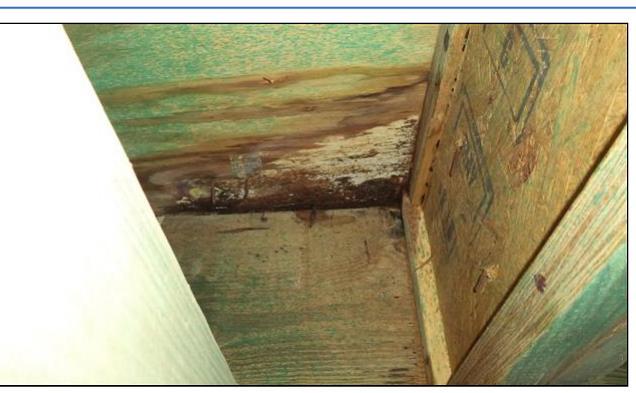
1.0 Item 2(Picture) Soft subflooring at the front of the space

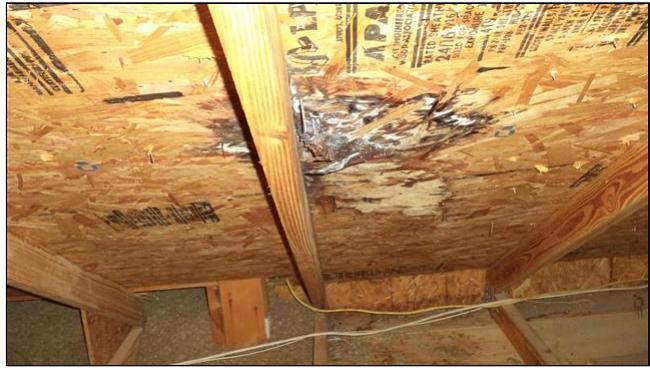
Two stains are present in the attic above the garage; the stain nearest the garage attic access is active and leaking. The decking is damaged and will also need repairing. It is unknown if the stain at the far end of this attic is active. A licensed roofer is needed for further inspection.

1.5 Item 1(Picture) Damaged decking in the garage attic from an active leak

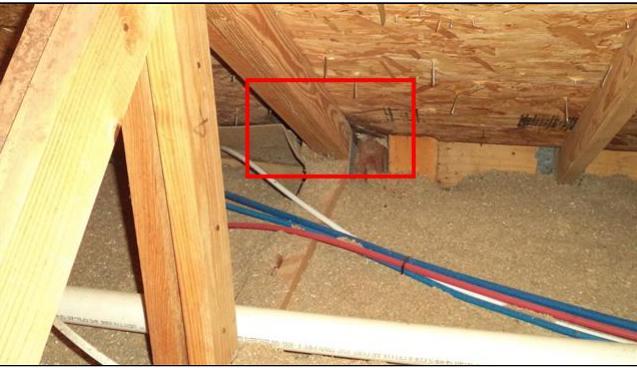
1.5 Item 2(Picture) Stain in the garage attic near the front of the home

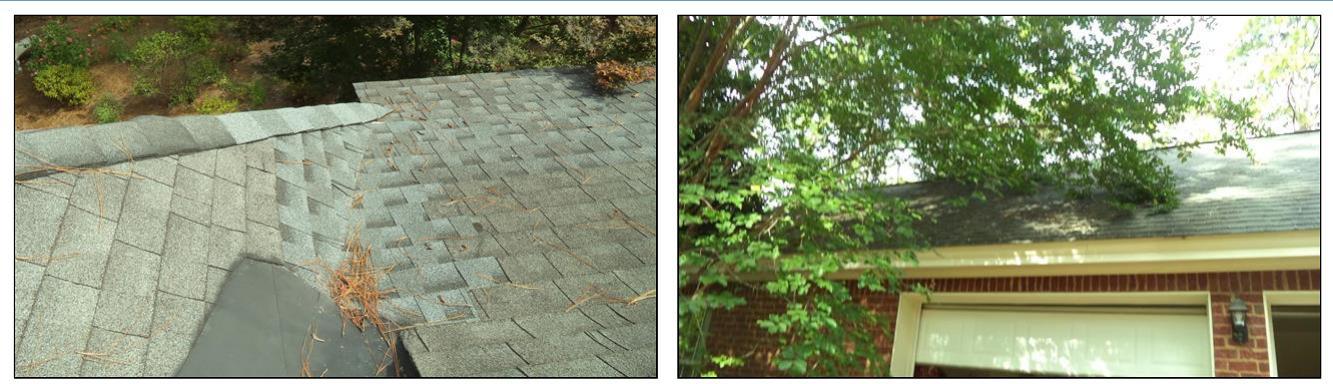
The shingles have a 30 year life expectancy; a licensed roofer is needed to inspect the center areas of roofing where the rooflines meet. This is a rubber / roll material. The roof above the garage is actively leaking. A shingle patch is present over the back of the kitchen / breakfast room.

3.0 Item 1(Picture) Shingle patch at the back

3.0 Item 2(Picture) Tree limbs touch the roof

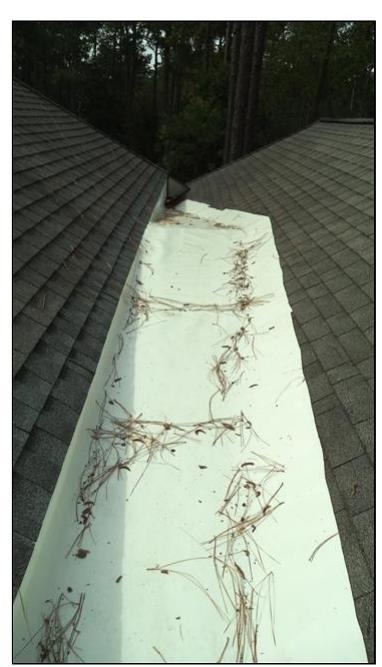
3.0 Item 3(Picture) Roofing above the master area between the rooflines

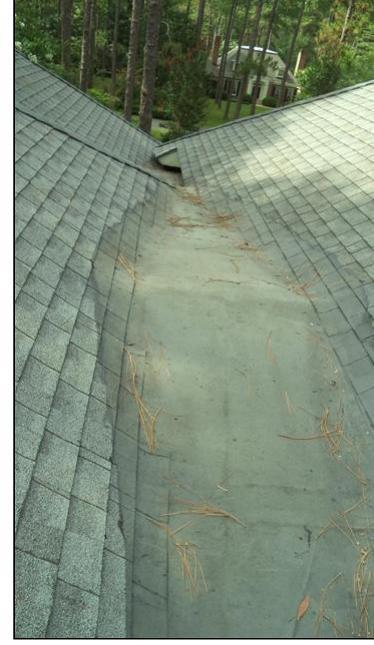
3.0 Item 4(Picture) Roofing between the rooflines over the garage

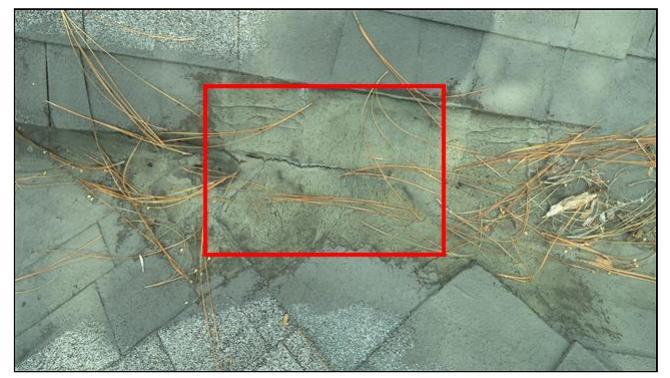
3.0 Item 5(Picture) Additional sealant suggested

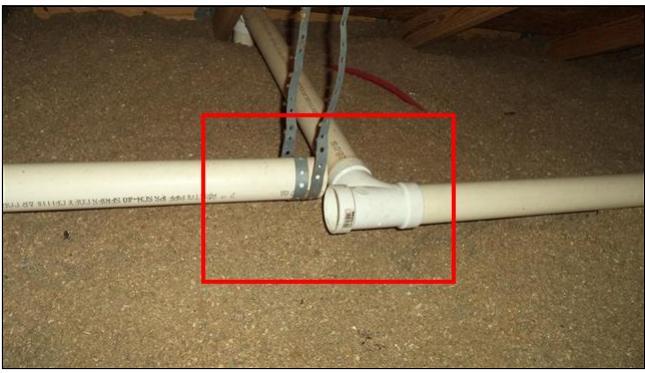
Over the garage, the vent stack has come disconnected and will need to re-connect to the main vent so all plumbing gases can escape to the exterior.

4.0 Item 1(Picture) Plumbing vent disconnected

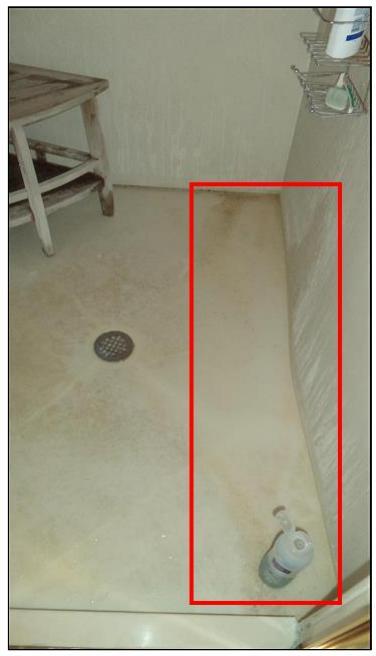
The master shower door does not properly close and latch; the top of this door is loose and does not secure in place. Also, there is a negative slope inside this shower with a bowed wall. In the crawlspace, heavy staining was found on the subflooring from prior leaking. A section of the structural support beam has been replaced under the shower. Repairs are suggested from a qualified professional so the water can properly slope to drain and the wall is no longer bowed.

4.1 Item 1(Picture) Standing water and bowed shower wall

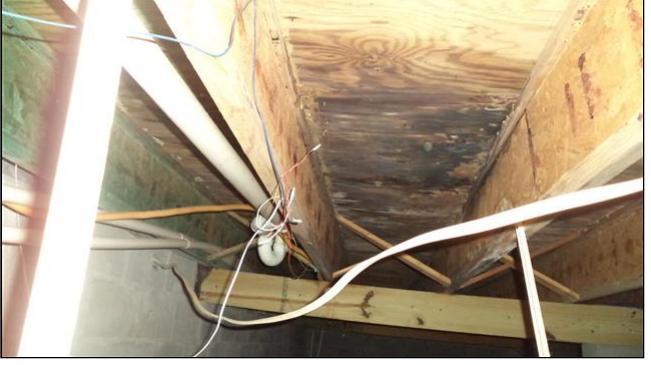
4.1 Item 2(Picture) Stained subfloor under the master shower

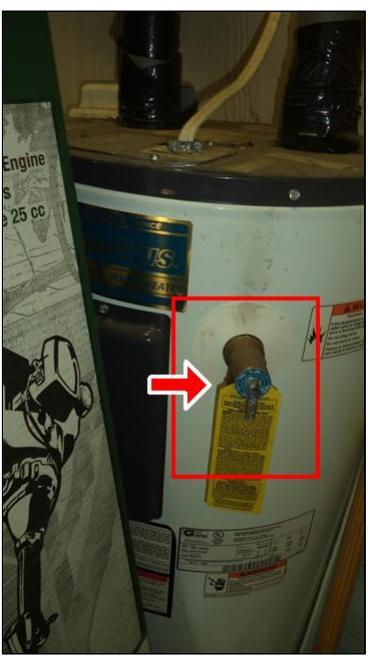
- 4.2 Hot Water Systems, Controls, Chimneys, Flues and Vents Inspected
- Both water heaters will need a PVC pipe attached to the TPR valves. The attached PVC is needed in case the tank needs to release temperature or pressure, it will release down the pipe instead of spew from the valve.

4.2 Item 1(Picture) Piping needed on the TPR valve

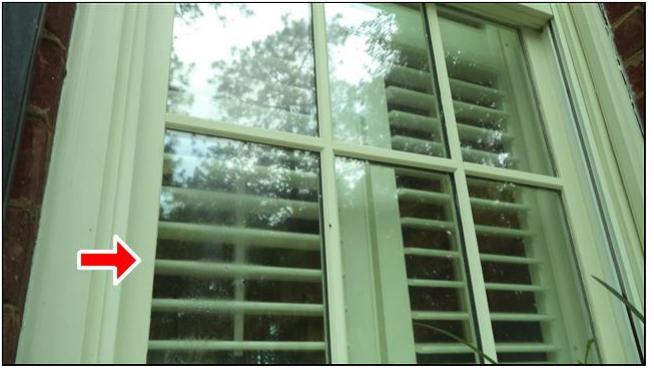
- 8.4 Windows (Representative number)
 - Inspected
- The front spare bedroom window has turned foggy and lost its seal in its lower pane. A small crack is present in this pane; replacement glass is suggested for correction.

8.4 Item 1(Picture) Foggy glass at front spare bedroom

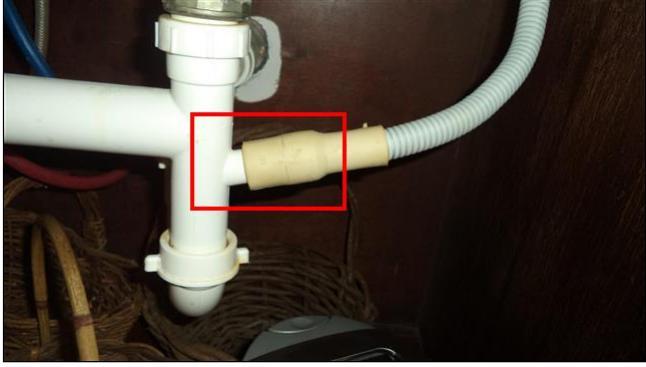
The dishwasher was not ran or cycled through because standing water is present inside the unit. Further evaluation is suggested from an appliance repair person to assess the drain line. Also, the drain line is not clamped. A clamp is needed.

10.0 Item 1(Picture) Clamp missing on the DW drain line

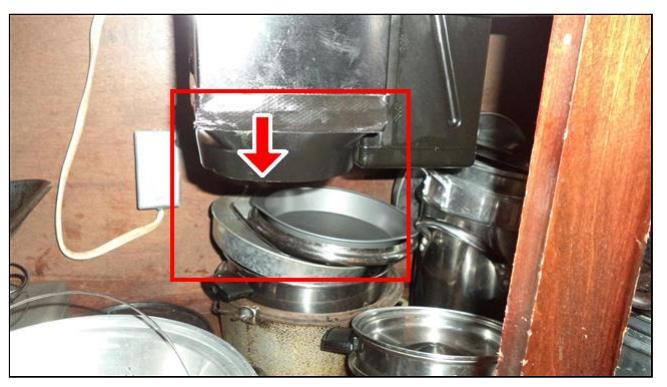
The down draft hood vent terminates into the cabinet below the stove top. It is best suggested that the exhaust terminate either in the crawlspace or exterior.

10.2 Item 1(Picture) Kitchen exhaust fan empties into the cabinet

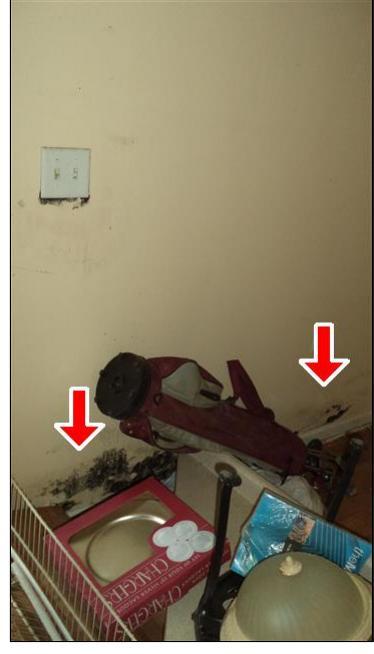
Mold is actively present in the back out building. Remediation is needed from a licensed removal company.

12.0 Item 1(Picture) Mold in the out building

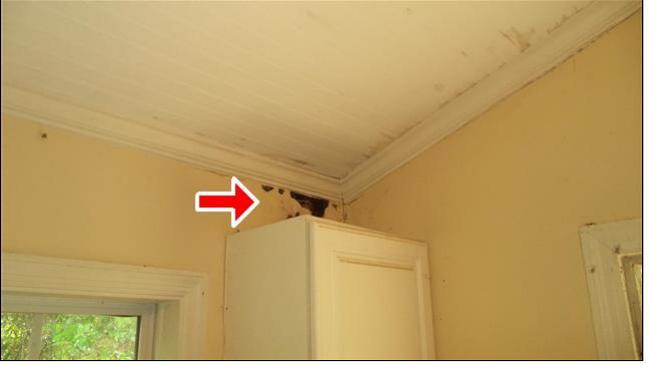
12.0 Item 2(Picture) Mold in the out building

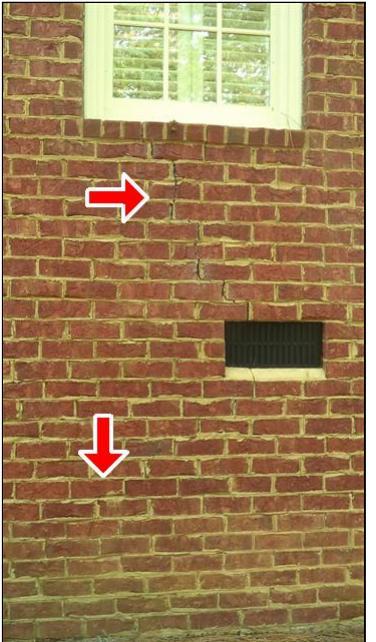
- 2.0 Wall Cladding Flashing and Trim Inspected
- A settlement crack is located in the brick at the left side of the home. All cracks in the siding are suggested for further evaluation from a licensed contractor.

2.0 Item 1(Picture) Cracked brick at the left side of the home

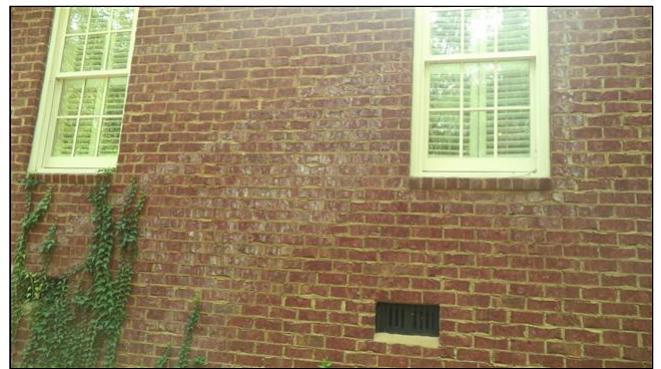
NOTE: Efflorescence is located on the brick at the left side of the home. This is a fine, white, powdery substance of water-soluble salts left on the surface of masonry as the water evaporates. This has not caused an issue or deficiency with the structure of the home.

2.0 Item 2(Picture) Efflorescence at the left side of the home

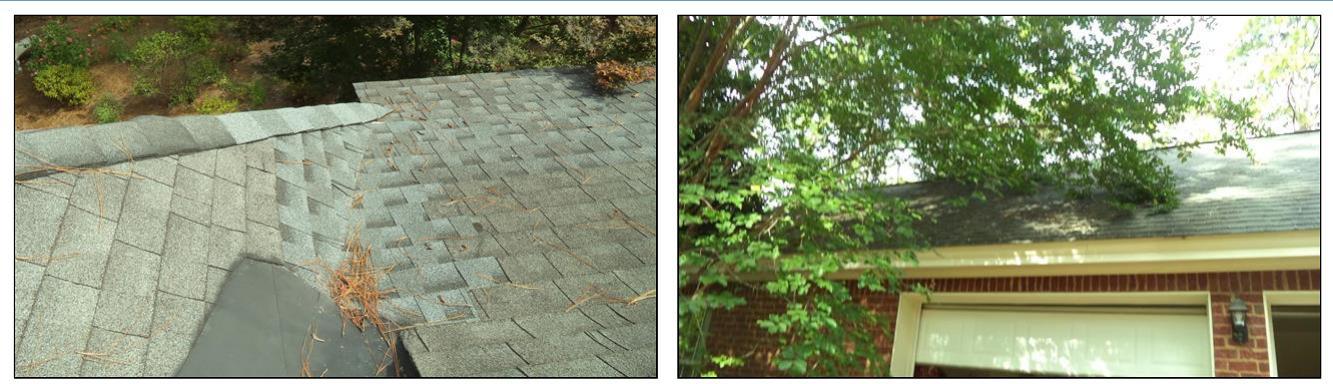
The shingles have a 30 year life expectancy; a licensed roofer is needed to inspect the center areas of roofing where the rooflines meet. This is a rubber / roll material. The roof above the garage is actively leaking. A shingle patch is present over the back of the kitchen / breakfast room.

3.0 Item 1(Picture) Shingle patch at the back

3.0 Item 2(Picture) Tree limbs touch the roof

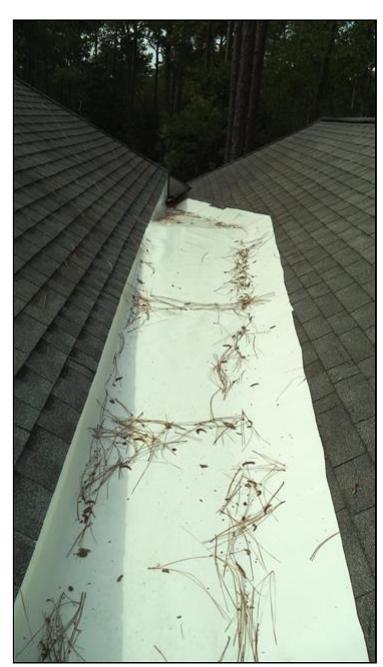
3.0 Item 3(Picture) Roofing above the master area between the rooflines

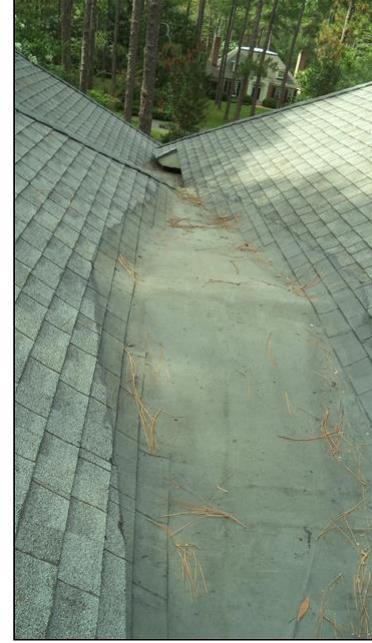
3.0 Item 4(Picture) Roofing between the rooflines over the garage

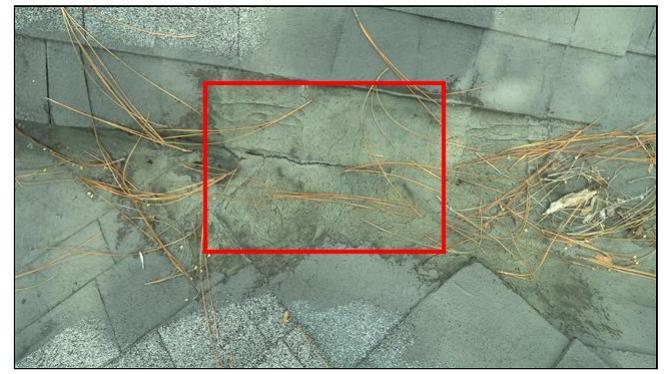
3.0 Item 5(Picture) Additional sealant suggested

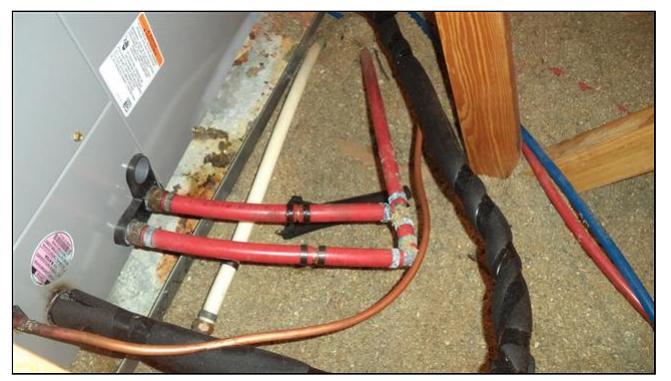
On all the air handlers, the drain lines are mostly pex piping instead of PVC material. A certified HVAC technician is suggested for another opinion on this type of material used for a condensate drain line.

7.1 Item 1(Picture) Pex piping used for drain line on the air handlers

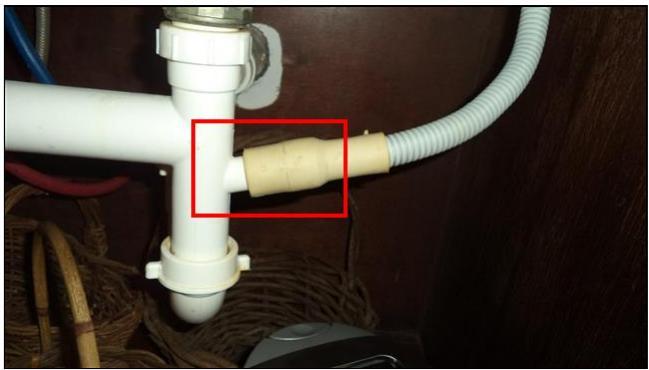
The dishwasher was not ran or cycled through because standing water is present inside the unit. Further evaluation is suggested from an appliance repair person to assess the drain line. Also, the drain line is not clamped. A clamp is needed.

10.0 Item 1(Picture) Clamp missing on the DW drain line
